A Low-Cost Smartphone-Based Photogrammetric Approach for Highway Pavement Defects Detection and Mapping

Abstract

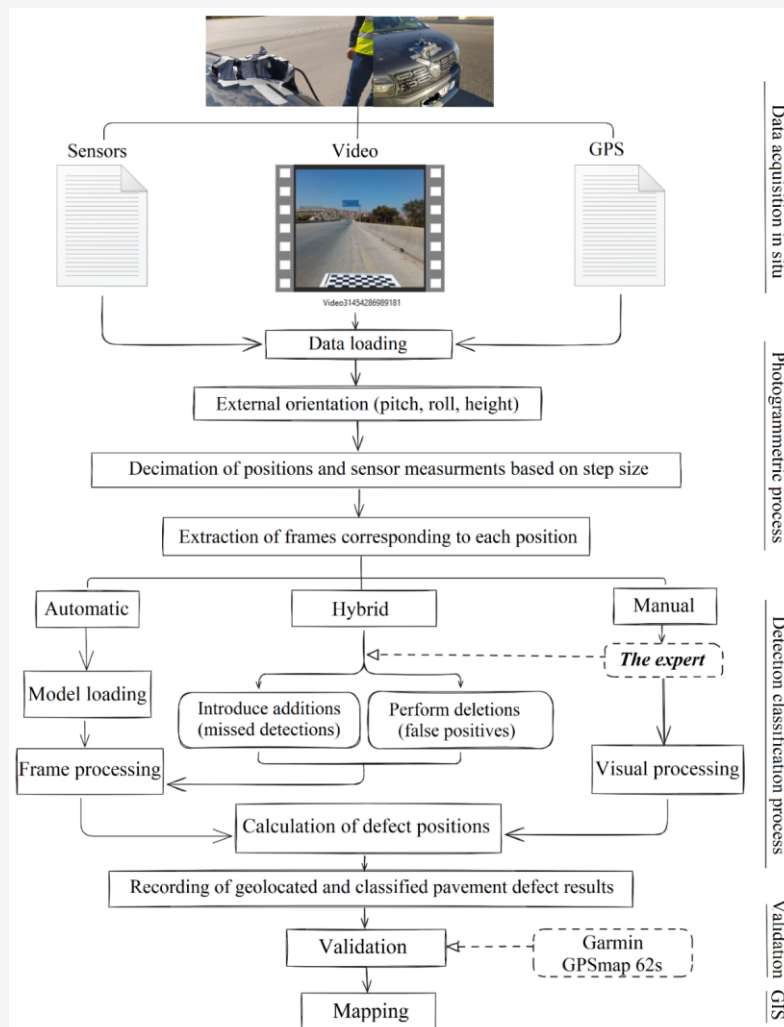
Figure 2: Workflow of the highway pavement defect detection methodology

Unlike the studies cited in the previous section, which used similar techniques for road defect detection, the methodology adopted in this study also relies on a photogrammetric approach, integrated into the processing workflow to geolocate the defects, thus enabling the creation of an accurate map depicting the condition of the studied road section at the end of the process. The methodological workflow, illustrated in Figure 2, integrates the synchronized acquisition of data (video, coordinates, and sensor information), followed by photogrammetric processing to assign precise metric properties to the frames. The detected pavement defects are then automatically identified, classified,

and geolocated using deep learning. The approach is subsequently validated before producing the final thematic maps of the detected defects.

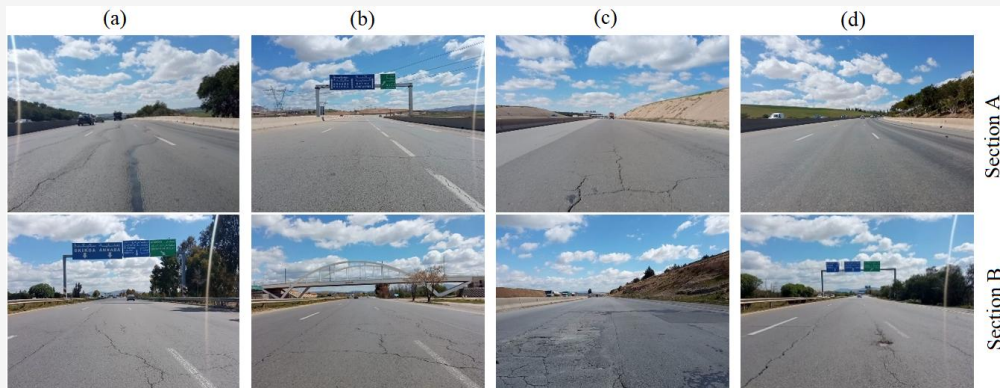
Figure 4: Principal types of defects affecting the studied sections (a) longitudinal cracks (b) transverse cracks (c) alligator cracking (d) rutting and pothole

pavement behavior in contrasting contexts. A study [29] on a 107 km segment of the A1 highway, located between Setif, Mila, and Constantine, part of which is also included in the present analysis, identified the appearance of longitudinal cracks just a few months after the infrastructure's commissioning in July 2010. A follow-up assessment, conducted over a period of one year starting in November 2010, revealed a continuous deterioration of the road condition. Three years later, further inspections confirmed that these defects had continued to develop and worsen, progressively compromising the strength and overall quality of the pavement. Building upon these findings, a comprehensive visual survey was conducted along the 41.36 km study section to evaluate the pavement condition and identify various forms of defect. This preliminary reconnaissance revealed four major types of deterioration affecting the studied sections: longitudinal cracks, the main type of defect observed; transverse cracks; alligator cracking; as well as rutting and potholes, predominantly located in areas with steep slopes and heavy traffic (Figure 4).

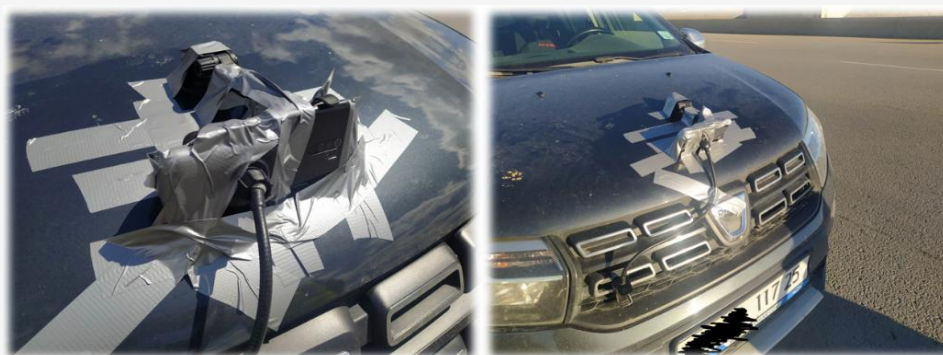
Figure 6: The implemented acquisition system

The field data acquisition mission was carried out in the morning of April 5, 2023, along the corridor of the highway section connecting Constantine to Mila (from KM150 to KM193), covering a total round-trip distance of 82.72 km. The operation was conducted at an average cruising speed of 60 km/h, ensuring an optimal balance between measurement continuity, data readability, and compliance with highway safety conditions. The acquisition system (Figure 5) implemented consisted of a Redmi 9 smartphone equipped with several onboard sensors (GPS, accelerometer, gyroscope, magnetometer), securely mounted on the hood of a Sandero Stepway vehicle using appropriate mechanical supports (Figure 6).

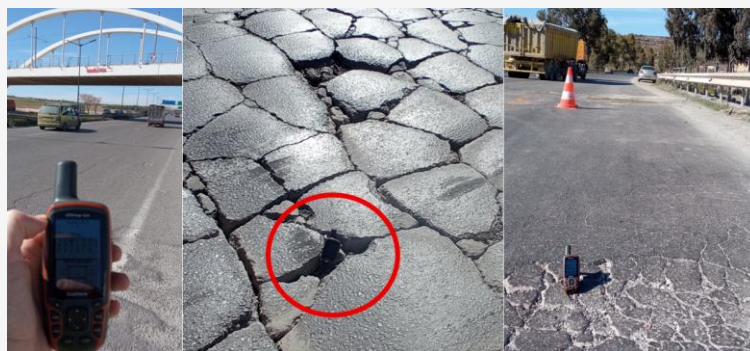
Figure 10: Garmin acquisition in situ (GPSmap 62s)

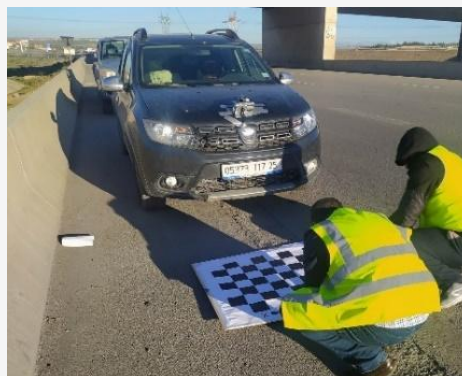
Figure 11: Smartphone camera calibration with Checkerboard Pattern

In the proposed approach, each detected defect is initially located within the image file coordinate system. After a calibration step, the interior and exterior orientation parameters are estimated, which can be done using a checkerboard placed in front of the camera (Figure 11). The primary goal of this step is to locate the camera relative to the vehicle's coordinate system. This allows for the back-projection of the detected defect coordinates onto the

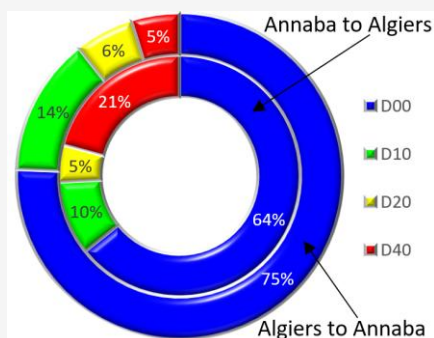
Figure 17: Geolocated defects by class

The table shows that longitudinal defects (D00, minor or superficial defects) are the most frequent in both directions, representing 76% of the defects from Algiers to Annaba and 64% from Annaba to Algiers (Figure 17).

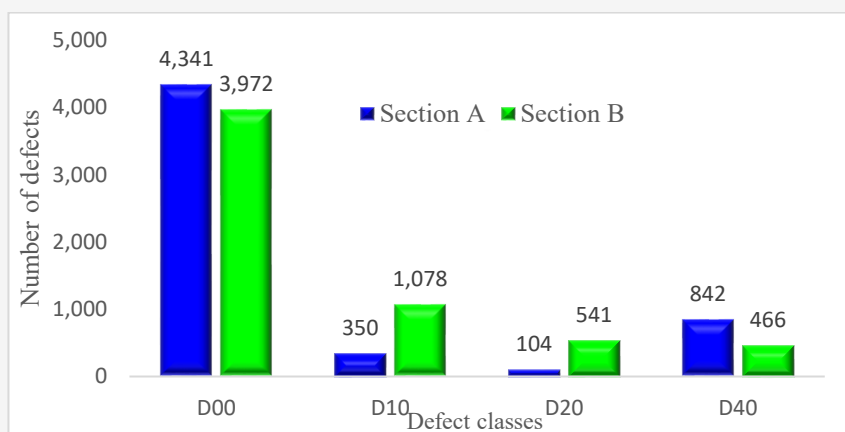
**Figure 18:** Geolocated defects by section**Table 5:** Number of defects by commissioning date

The number of defects for the two studied sections is presented in Table 4 and Figure 18.

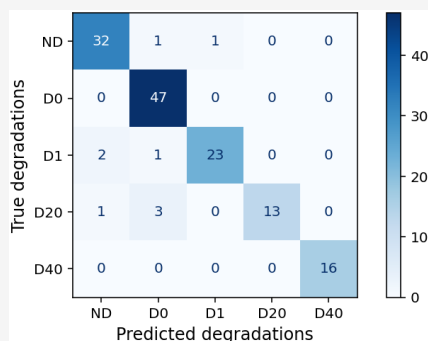
**Figure 19:** Confusion matrix

The confusion matrix and the corresponding evaluation report, calculated by the implemented program, are illustrated in Figure 19 and Table 6 respectively. Table 6 presents an F1-score of 93.27%, indicating a high overall performance of the approach, demonstrating a robust capability to accurately identify and localize the different types of defects. A recall of 91.81% underscores the

Taken together, these metrics underline the robustness of the proposed system. The confusion matrix shows that, among the 34 ND points collected in situ, only 2 points were misclassified by the system, being respectively assigned to the D10 and D00 classes. The defects of type D00, although correctly identified and localized, were associated with a few false positives, primarily originating from the D20 class. Additionally, a D20 defect was not detected and was erroneously classified as non-degraded (ND class). The relatively lower recall of the D20 class observed in Table 6 is explained by the limited number of D20 validation samples (76.47%, based on 17 samples) and the intrinsic ambiguity of this defect category. A D20 defect, of a moderate nature, can be perceived as a combination of D00 and D10 cracks. This characteristic makes its detection more complex; consequently, the system may underestimate or misidentify this type of defect. As a result, the combination of less severe cracks may sometimes be incorrectly classified into a lower category, such as D00, leading to omissions in detecting moderate D20 defects, even though all predicted D20 samples are correctly classified (100% precision). The omission of one D20 defect point as ND does not necessarily indicate a detection failure, but is likely due to the decametric precision of GPS, with the defect located slightly beyond the 10 m matching radius. Although these defects do not present an immediate danger, they may become problematic in the long term if not addressed.
