Crack Detection using Pretrained Deep Learning under Varying UAV Imaging Configurations

Abstract

Keywords: Crack detection, Deep Learning, iTwin Capture Modeler, Imaging Configuration, UAV Photogrammetry

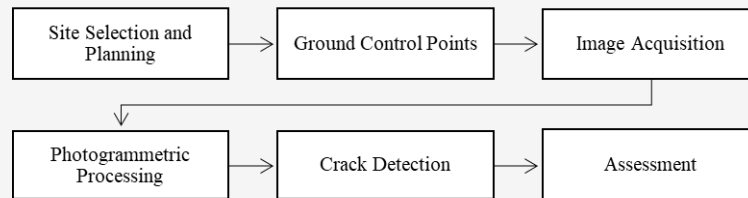
Figure 1: Crack detection using UAV study workflow

By referring to Figure 1, this study began with site selection and planning, where a suitable building with visible cracks was identified for monitoring. Ground control points (GCPs) were established to enhance georeferencing accuracy during the photogrammetric process. Following this, images were acquired using UAVs based on different camera configurations. The collected images were subsequently processed using photogrammetry to generate 3D models. These models were then analysed using deep learning techniques for crack detection. Finally, an assessment was conducted to evaluate the reliability of the detection results based on the different UAV imaging setups. The following subsections explain the research methodology in detail.

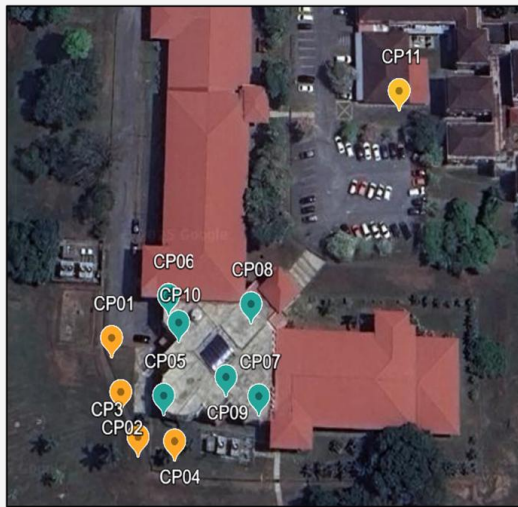
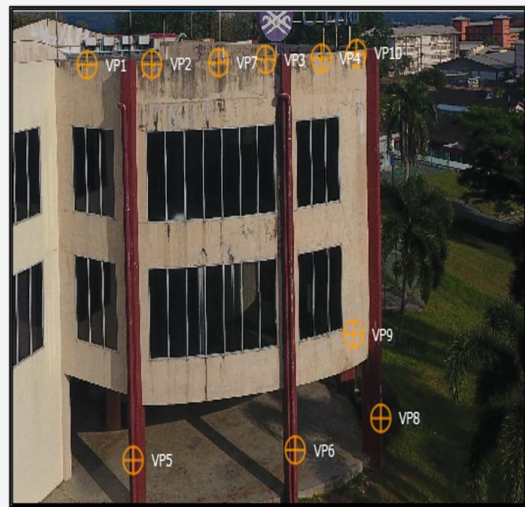
Figure 3: The distribution of Ground Control Points (GCP): (a) The distribution of Ground Control Points (labelled as CP) on the ground, (b) The distribution of Verification Points (VP) on the façade wall

Therefore, this study also experimented with a slanting configuration to capture both the concrete rooftop and the façade of the building for a complete 3D model reconstruction. The camera was set at a 60° angle and flown at the same altitude as in the vertical configuration. Meanwhile, the horizontal configuration refers to the side-view capture of the building façade, a technique that is commonly implemented for structural inspection and excludes the top view. For this configuration, images were captured at distances of 10m, 20m, and 30m from the building surface to evaluate the effect of proximity on detection performance. Table 2 summarizes the camera configurations used in this study, while Figure 3 shows the distribution of GCP and VP.

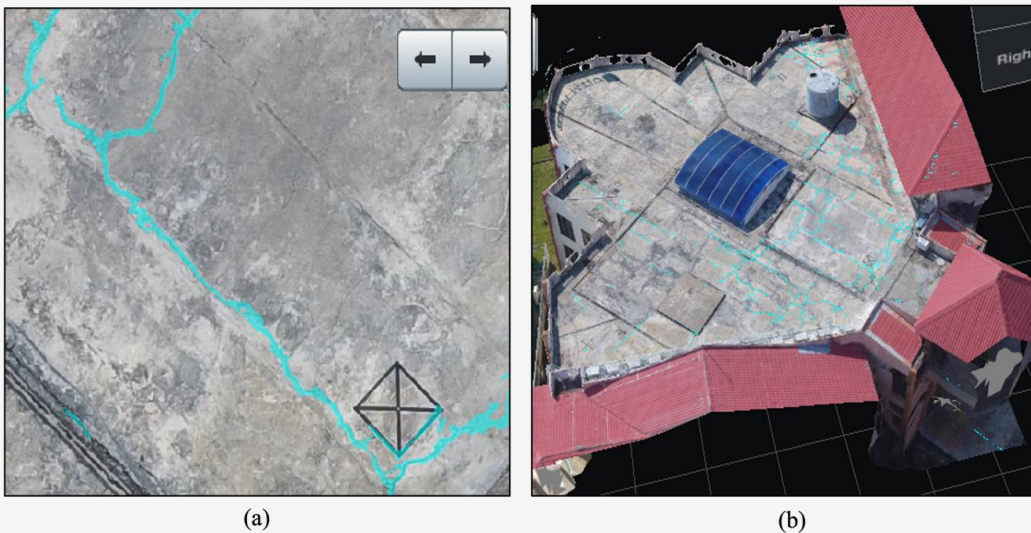
Figure 4: The detected cracks are represented as cyan vectors:

- (a) The detection was initially performed on 2D images, and
 (b) The same detected vector highlighted in red box projected onto the respective location on the 3D model

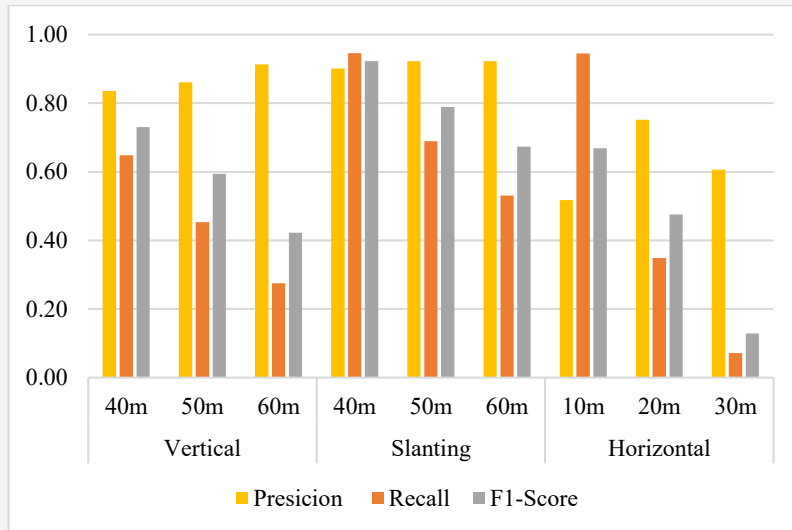
**Figure 5:** Precision, recall, and F1 score comparison across camera configurations

Configuration	Height/ Distance (m)	Precision %	Recall %	F1 score %
Vertical	40	83.57	64.84	73.02
	50	86.11	45.35	59.41
	60	91.29	27.48	42.24
Slanting	40	90.10	94.56	92.28
	50	92.24	68.93	78.90
	60	92.27	53.05	67.37
Horizontal	10	51.77	94.48	66.89
	20	75.14	34.83	47.60
	30	60.62	7.21	12.88

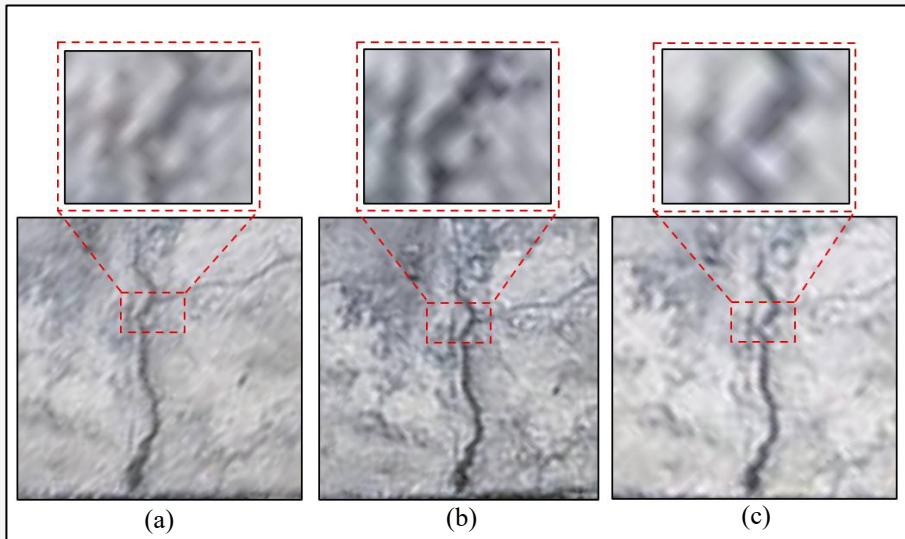
Figure 6: Close-up images of the same crack at (a) 40m, (b) 50m, and (c) 60m. Higher altitudes reduce image resolution, making cracks less visually distinct and harder for the model to detect

The vertical configuration simulated conventional photogrammetric mapping, in which the camera was oriented directly downward. At 40m, the model yielded a moderate F1 score of 73.02%, with a precision of 83.57% and a recall of 64.84%. However, as the flight altitude increased to 50m and 60m, the recall values dropped sharply to 45.35% and 27.48%, respectively, despite a continuous increase in precision that reached 91.29% at 60m. This trend indicates that the model becomes more conservative at higher altitudes. While it successfully filtered out false detections, it also failed to identify many actual cracks. The main factor contributing to this performance drop is the reduced image resolution at higher altitudes, which results in the loss of fine texture and edge features required by the pretrained model to recognize subtle crack patterns. As the flight altitude increased from 40m to 60m, the corresponding image resolution decreased from 16 mm/pixel to 25 mm/pixel, as shown in Figure 6. Although the cracks remain visually discernible to the human eye, the reduced pixel-level detail impacts the model's ability to detect them, especially when

those cracks are narrow or faint. However, the lower resolution at higher altitudes also reduces the model's sensitivity to surface noise and minor artifacts, which in turn leads to fewer false positives and hence higher precision values.

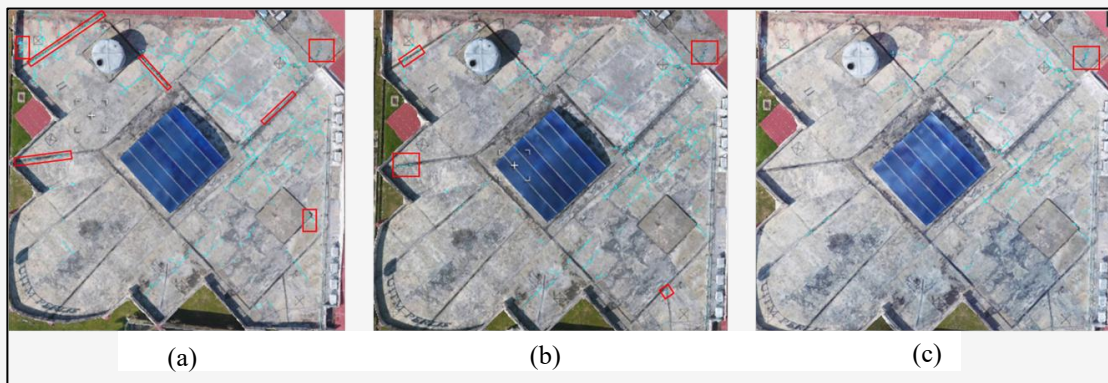
Figure 7: Crack detection at (a) 40m, (b) 50m, and (c) 60m. High resolution at 40m causes over-detection (red boxes), while at higher altitudes the model's sensitivity reduces false positives but may miss finer cracks

This effect is further illustrated in Figure 7, which shows the spatial distribution of detected cracks across the building surface at different altitudes. At 40m, the detection coverage is dense and widespread, especially in regions highlighted by red boxes, many of which correspond to false positives. As the altitude increases to 50m and 60m, the number of such detections decreases noticeably. At 60m, the detection becomes sparse or absent in several regions, indicating the model's reduced sensitivity due to lower resolution. However, this also results in fewer false crack detections, contributing to the higher precision observed at greater heights. This trade-off confirms the model's conservative behaviour at higher altitudes, as it successfully avoids misclassifying non-crack textures as cracks but simultaneously risks failing to detect fine or incipient cracks.

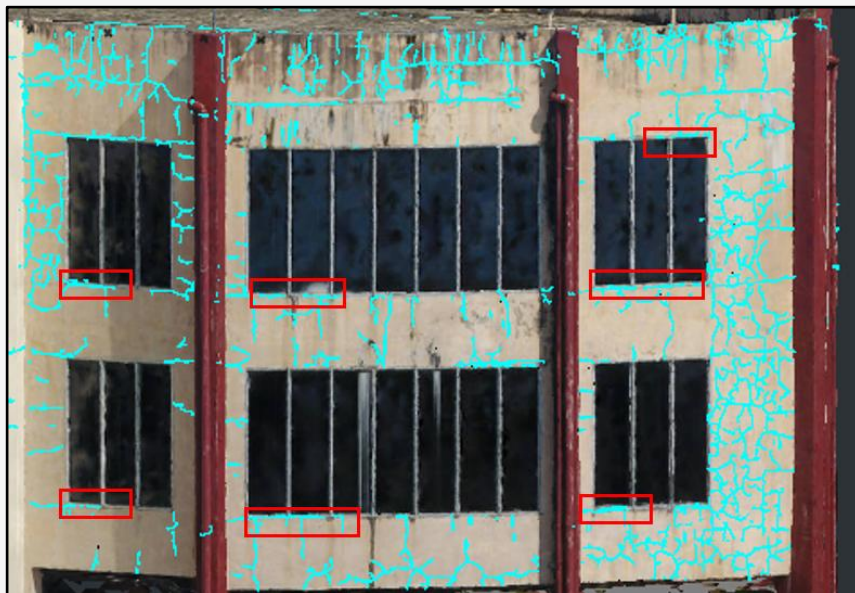
Figure 8: Detection output for the horizontal configuration at 10m. The model incorrectly identified window frames and façade elements as cracks due to high image resolution and the presence of texture-rich surfaces

The horizontal configuration, involving side-view imaging at 10m, 20m, and 30m from the building façade, revealed a contrasting detection pattern compared to the vertical setup. At 10m, the model yielded a recall of 94.48%, indicating high sensitivity to actual cracks. However, precision was relatively low at 51.77%, resulting in an F1 score of 66.89%. As the distance increased, both precision and recall declined further, leading to a significant drop in overall performance. Unlike the vertical configuration, where the camera captured mostly flat concrete surfaces with minimal texture, the horizontal setup introduced a texture-rich environment. Vertical imaging typically involves rooftops or pavement areas with uniform tone and fewer visual distractions, which allows the model to focus more effectively on crack features. In contrast, the side-view images of the building façade included various architectural elements such as window frames, joint lines, and decorative grooves.

Although horizontal imaging at close range provided high image resolution, the abundance of linear and edge-like patterns within the scene increased the chances of false positives. As shown in Figure 8, the model incorrectly detected window edges and repetitive façade structures as cracks. The presence of strong contrast between windowpanes, shadows, and wall boundaries further contributed to the confusion. These visual complexities reduced the model's precision and highlighted the challenge of applying pretrained detection models in scenes with diverse background textures. Among all configurations tested, the slanting orientation at 40m yielded the highest overall performance, with an F1 score of 92.28%, a precision of 90.10%, and a recall of 94.56%. Even at increased altitudes of 50m and 60m, the model maintained a consistently high level of precision, exceeding 92%, along with a respectable recall.
